# Biuletyn Techniczny

Numer:	OSB11-04-051
Data:	2 listopada 2011
Wersja:	00

## Cruze J300 – Piszczenie tylnych zacisków hamulcowych

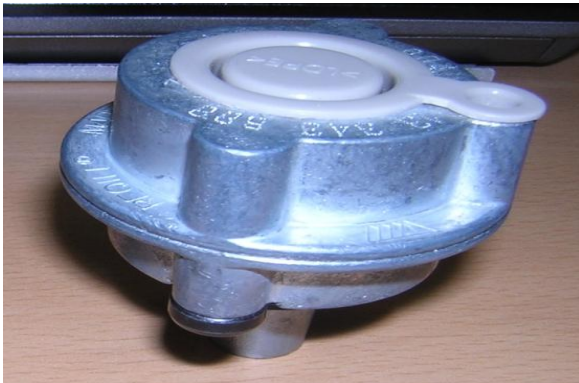
Tłumik (2szt na auto)

Zainstalować zestaw tłumików (13337450)

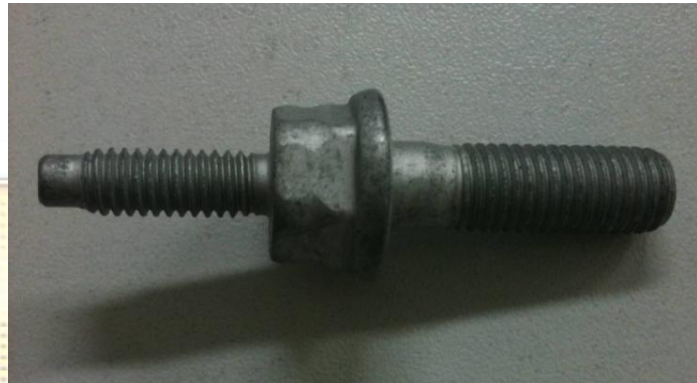
Śruba tłumika (2 szt na auto)
